MANAHAWKIN LAKE DAM

NJ 00057

PHASE 1 INSPECTION REPORT NATIONAL DAM SAFETY PROGRAM

PHASE I REPORT
NATIONAL DAM SAFETY PROGRAM

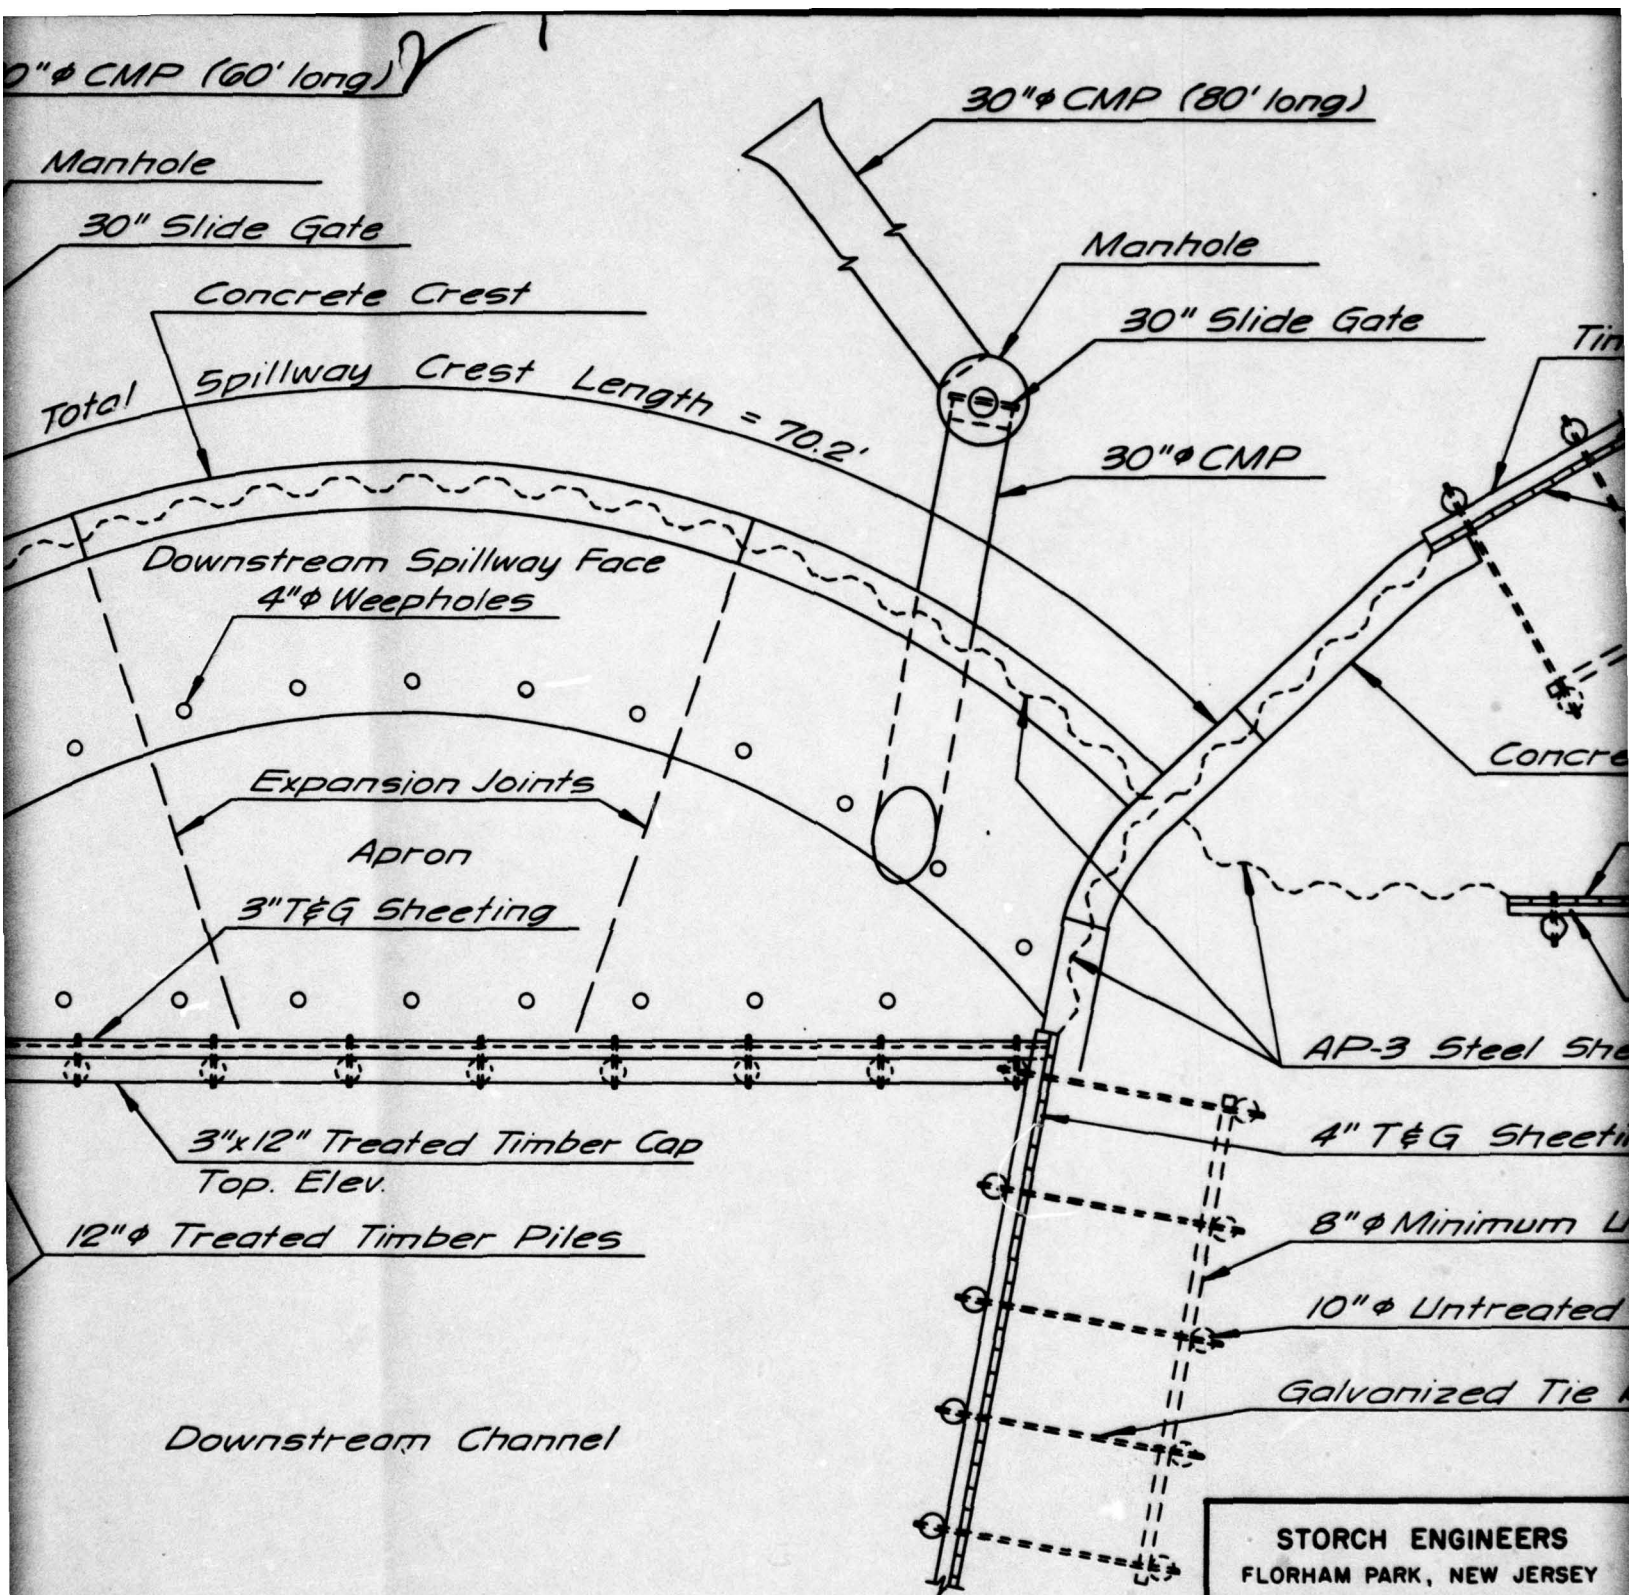
INSPECTION AND EVALUATION
SPILLWAY
MANAHAWKAN

The concrete spillway appears to be structurally sound, although its surface appears to be slightly eroded. The spillway surface should be protected and any cracks and spalls not visible at the time of inspection should be repaired in the near future by sand blasting, grouting where needed and coating with epoxy.
